**Flood Control Project Maintenance
Levee Inspections**

Fall 2016 Levee Maintenance Deficiency Summary Report

Reclamation District No. 0341 Sherman Island

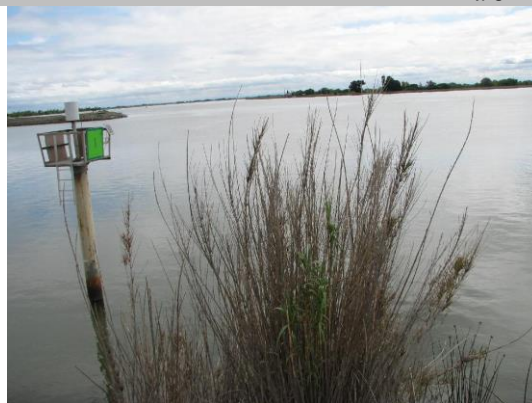
Photo 1 of 2 : UCIP_FA_2016_22063_37640.jpg

Comment Code					
Inspector Comment					
FS_ID:22063 DS_ID:24215 EP_NO: N/A Repair Type: Non-Urgent Crossing Status: Found UCIP Comments: Dense vegetation limits the inspector's visibility to identify signs of pipe failure (leaks) along the slopes. Recommend removing vegetation along pipe alignment to conduct proper inspection of structure and appurtenances. FIELD_STRUCT_DESC: 30-inch steel drainage pipe through the levee, 11.1 feet below the crown. CM cutoff wall around pipe at center of levee. Siphon breaker on both sides. Pump on landward side approximately 300 feet from landward toe. Pipe exposed on both levee slopes. Rock revetment on waterward slope. (USACE-1962). This entry matches the Drainage or Irrigation Structure referenced in O&M manual (HLM 0.0). Marine Station number 1 located on waterward side with attached small solar panel on top. FS Date: 5/5/2009

Marine station posts in river identified as Station 1 near crossing.

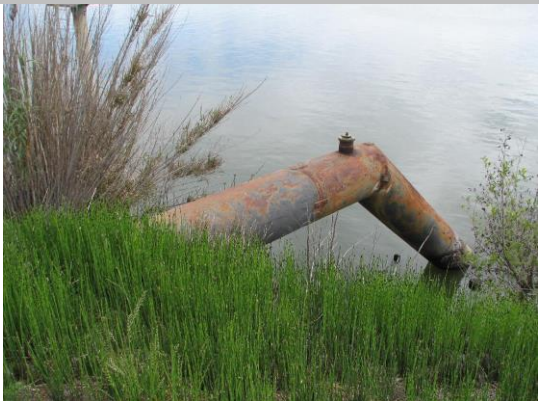
Photo 2 of 2 : UCIP_FA_2016_22063_37644.jpg

View of pipe and siphon breaker located on waterward side--dense vegetation on slope.

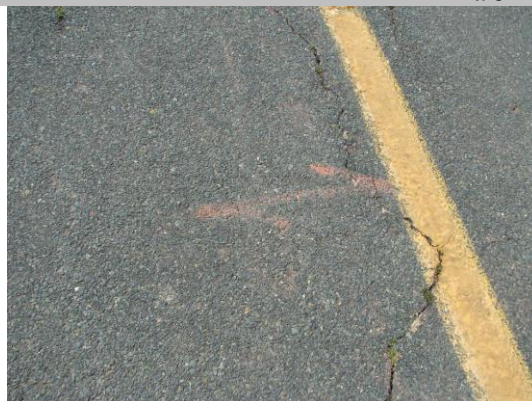
Photo 1 of 2 : UCIP_FA_2016_22064_37647.jpg

Underground Service Alert (USA) markings on road surface indicating line is still present.

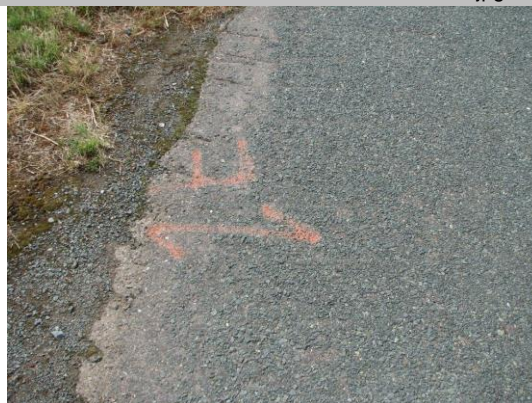
Photo 2 of 2 : UCIP_FA_2016_22064_37646.jpg

Underground Service Alert (USA) markings on road shoulder.

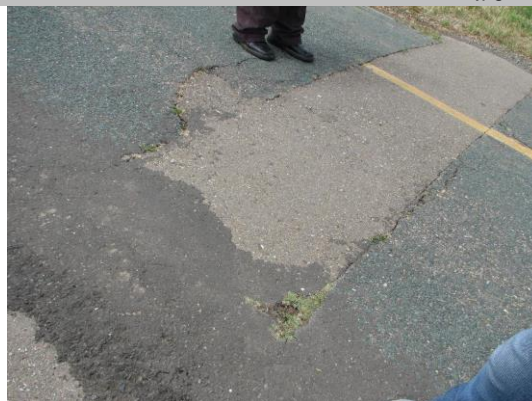
Photo 1 of 2 : UCIP_FA_2016_22068_37654.jpg

FS_ID:22068
DS_ID:24111
EP_NO: 1477
Repair Type: Non-Urgent
Crossing Status: Found
UCIP Comments: Dense vegetation limits the inspector's visibility to identify signs of pipe failure (leaks) along the slopes. Recommend removing vegetation along pipe alignment to conduct proper inspection of structure and appurtenances.
FIELD_STRUCT_DESC: 10-inch steel pipe through the levee, 1.8 feet below the crown. Pipe is encased in 12-inch CM conductor pipe under crown. Pump on landward side. Air vent and metal distribution box with gate on the landward side. Rock revetment on the waterward slope. (USACE-1962). This entry matches the Drainage or Irrigation Structure referenced in O&M manual (HLM 0.50). 30-feet of pipe under crown was replaced and encased in CM pipe under Permit No. 1477 (1950). FS Date: 5/5/2009

Cut along pipe alignment--unknown repair or maintenance date.

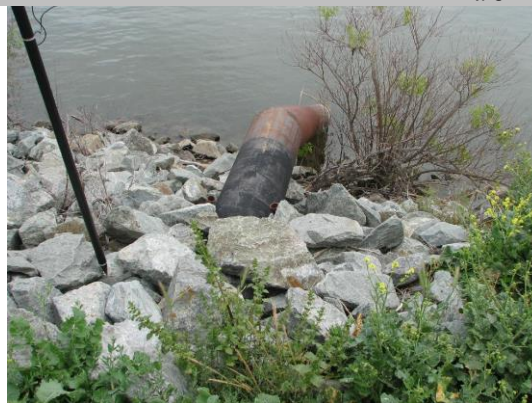
Photo 1 of 2 : UCIP_FA_2016_22070_37664.jpg

LM Start	1.07	Rating **	M	Issue No.	30
LM End	1.07	Issue Type +	En	Location *	WS
Category	Supplemental			GPS Latitude/Longitude	
				Start	End
Item	DWR UCIP Field Study			38.100972 °	38.100972 °
				-121.686813 °	-121.686813 °
DWR ID					
Comment Code					
Inspector Comment					
FS_ID:22070 DS_ID:24113 EP_NO: 11095 Repair Type: Non-Urgent Crossing Status: Found UCIP Comments: Dense vegetation limits the inspector's visibility to identify signs of pipe failure (leaks) along the slope. Recommend removing vegetation along pipe alignment to conduct proper inspection of structure and appurtenances. FIELD_STRUCT_DESC: 18-inch pipe sleeved through 24-inch pipe through the levee, 4.0 feet below the crown. Air vent and monitoring well on landward side. Pipe exposed on the waterward slope. This pipe was retained under ABO No. 11095 (1975). FS Date: 5/5/2009

View of pipe located on waterward side.

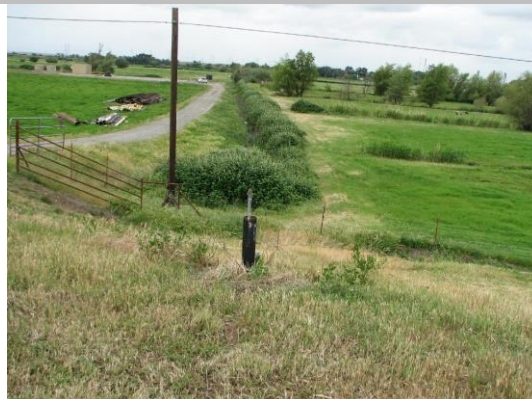
Photo 2 of 2 : UCIP_FA_2016_22070_37663.jpg

View of landward side--visible standup pipe on slope.

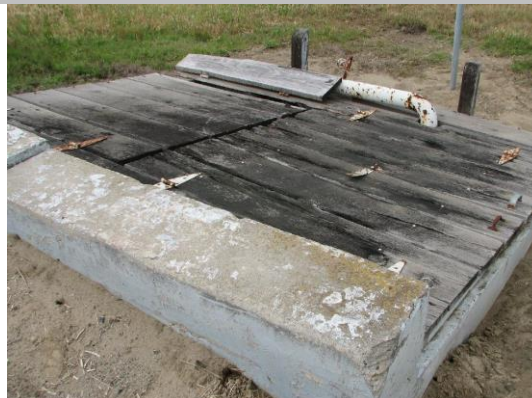
Photo 1 of 2 : UCIP_FA_2016_22074_37675.jpg

Concrete box located on landward side.

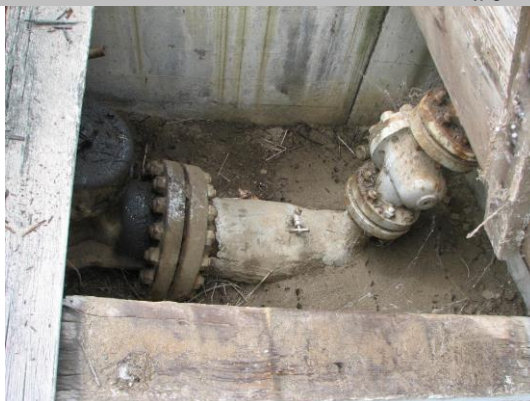
Photo 2 of 2 : UCIP_FA_2016_22074_37672.jpg

Inside view of vault located on the landward side.

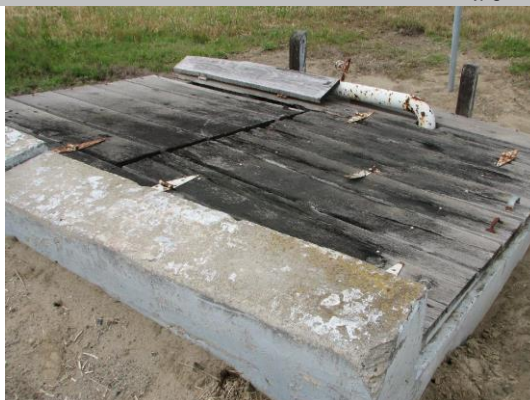
Photo 1 of 2 : UCIP_FA_2016_22076_37680.jpg

Concrete box located on landward side.

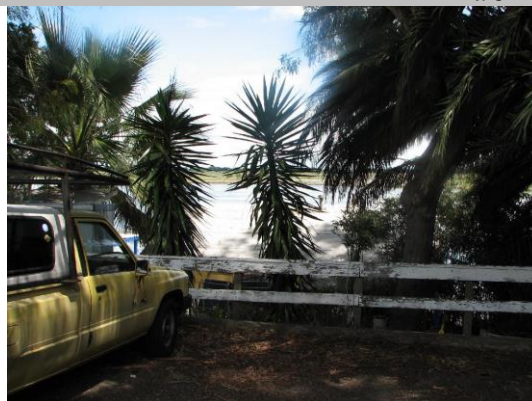
Photo 1 of 2 : UCIP_FA_2016_22086_37706.jpg

LM Start	1.96	Rating **	M	Issue No.	35
LM End	1.96	Issue Type +	En	Location *	WS
Category	Supplemental			GPS Latitude/Longitude	
				Start	End
Item	DWR UCIP Field Study			38.113641 °	38.113641 °
				-121.684112 °	-121.684112 °
DWR ID					
Comment Code					
Inspector Comment					
FS_ID:22086 DS_ID:24116 EP_NO: 11103 Repair Type: Non-Urgent Crossing Status: Found UCIP Comments: Unable to determine if crossing is the same as permitted under permit no. 11103. Need to contact owner and determine status of crossing under permit no. 11103. Believe steel conduit is exposed on landward side. FIELD_STRUCT_DESC: 1.5-inch iron water pipe and 3.5-inch electrical steel conduit through the levee, both 3.0 feet below the crown. Pressure system and service pole on landward slope. Fishing resort on waterward side. This pipe was retained under ABO No. 11103 (1975). FS Date: 5/5/2009

View of waterward side.

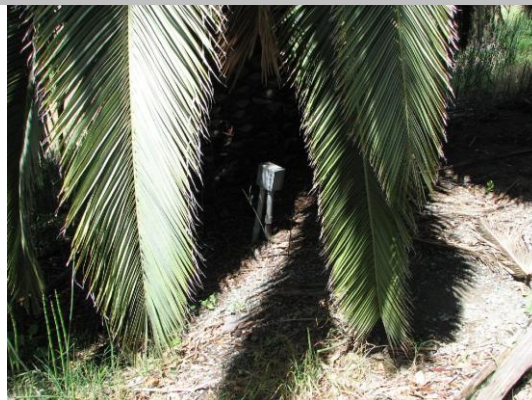
Photo 2 of 2 : UCIP_FA_2016_22086_37704.jpg

Power connection on waterward side no other appurtenances found.

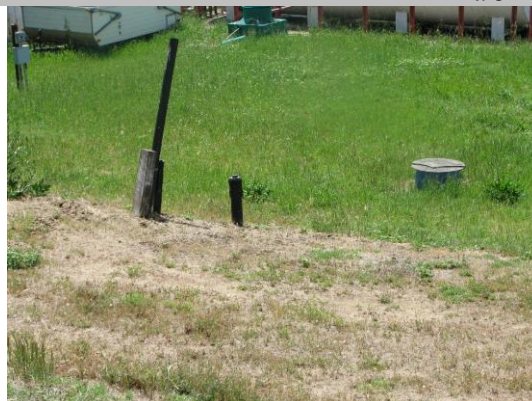
Photo 1 of 2 : UCIP_FA_2016_22091_37712.jpg

LM Start	2.00	Rating **	M	Issue No.	40
LM End	2.00	Issue Type +	En	Location *	WS
Category	Supplemental			GPS Latitude/Longitude	
				Start	End
Item	DWR UCIP Field Study			38.114092 °	38.114092 °
				-121.684524 °	-121.684524 °
DWR ID					
Comment Code					
Inspector Comment					
FS_ID:22091 DS_ID:24117 EP_NO: 5427 Repair Type: Non-Urgent Crossing Status: Indicator Found UCIP Comments: Unable to find pipe or sump pump. Indicators found on landward side include potential septic tank and observation well. Need to contact owner of crossing to determine status of crossing. FIELD_STRUCT_DESC: 1 of 2: 4-inch diameter pipe sleeved through 6-inch pipe through the levee, 3.7 feet below the crown. Sump pump on waterward slope. Septic tank and observation well on the landward side. (Permit No. 5427-1966) FS Date: 5/5/2009

View of potential observation well on landward side.

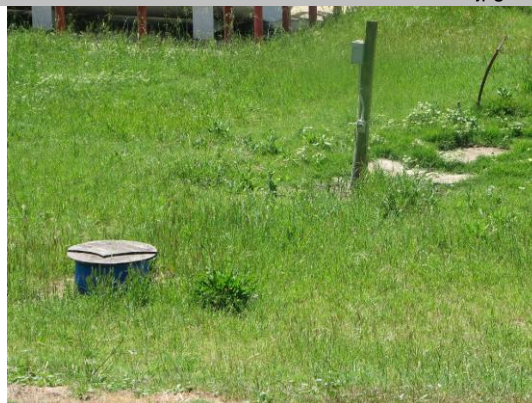
Photo 2 of 2 : UCIP_FA_2016_22091_37711.jpg

Stand pipe (potential observation well) and concrete pad located on landward side.

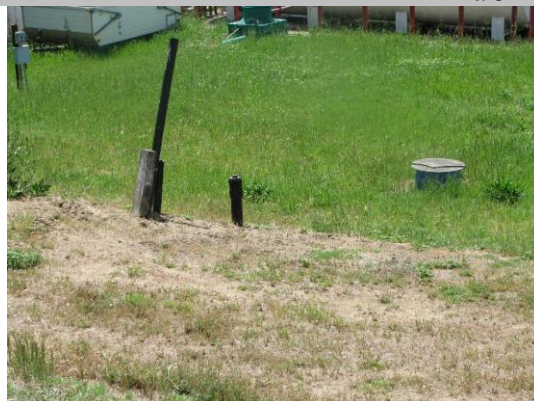
Photo 1 of 2 : UCIP_FA_2016_22093_37717.jpg

LM Start	2.00	Rating **	M	Issue No.	41
LM End	2.00	Issue Type +	En	Location *	WS
Category	Supplemental			GPS Latitude/Longitude	
				Start	End
Item	DWR UCIP Field Study			38.114092 °	38.114092 °
				-121.684524 °	-121.684524 °
DWR ID					
Comment Code					
Inspector Comment					
FS_ID:22093					
DS_ID:24237					
EP_NO: 5427					
Repair Type: Non-Urgent					
Crossing Status: Indicator Found					
UCIP Comments: Signs of electrical connection boxes. Unable to determine if these boxes are associated to crossing. Need to contact owner to determine status of crossing.					
FIELD_STRUCT_DESC: 2 of 2: Five 1 to 1.5-inch pipes through the levee, 3.7 feet below the crown. Pump on waterward slope. Septic tank and observation well on the landward side. (Permit No. 5427-1966)					
FS Date: 5/5/2009

Electrical conduit and box located on left corner of picture.

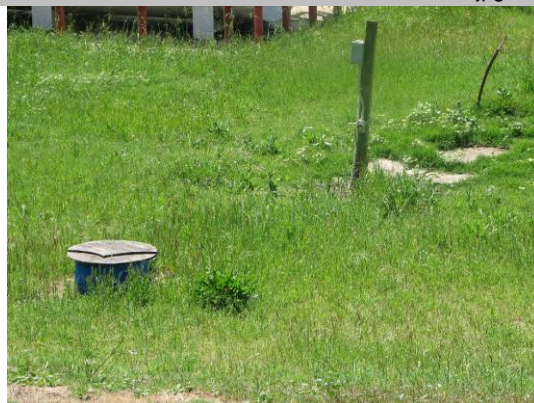
Photo 2 of 2 : UCIP_FA_2016_22093_37716.jpg

Electrical connection visible next to concrete pad--right corner.

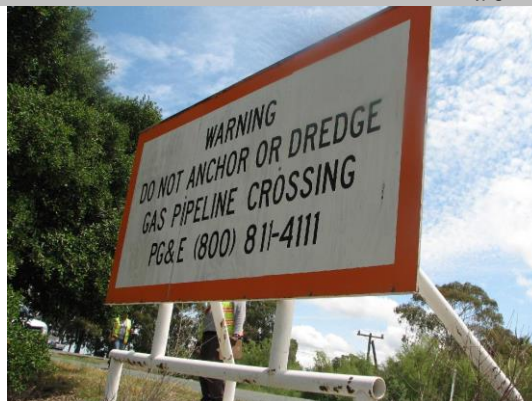
Photo 1 of 2 : UCIP_FA_2016_22094_37719.jpg

FS_ID:22094
DS_ID:24119
EP_NO: 960
Repair Type: Non-Urgent
Crossing Status: Indicator Found
UCIP Comments: Need to contact owner to determine last inspection and status of crossing.
FIELD_STRUCT_DESC: 1 of 2: 10-inch gas line through the levee, 2.0 feet below the crown. Cutoff wall around pipes at center of levee. Valve pit on landward shoulder, with 2-inch drain pipe along landward slope. Contact information for PG&E 800-811-4111. Location marker on waterward slope. (Permit No. 960-1944) This entry matches the Drainage or Irrigation Structure referenced in O&M manual (HLM 2.04). Pipe video inspected by PG&E under Permit No. 15319 (1990).
FS Date: 5/5/2009

Pipeline marker located on waterward shoulder.

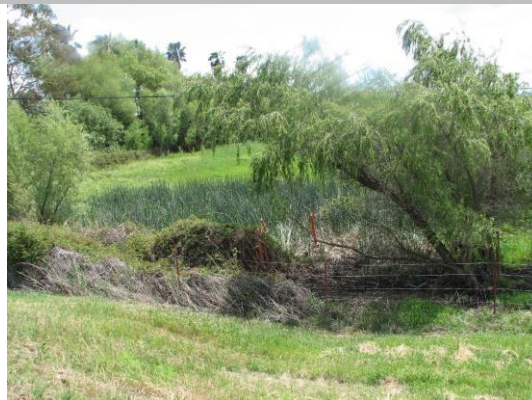
Photo 2 of 2 : UCIP_FA_2016_22094_37718.jpg

Landward markers visible near levee toe.

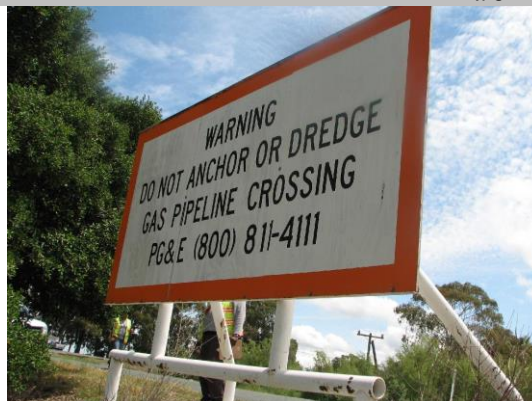
Photo 1 of 2 : UCIP_FA_2016_22098_37724.jpg

Comment Code					
Inspector Comment					
FS_ID:22098					
DS_ID:24242					
EP_NO: 960					
Repair Type: Non-Urgent					
Crossing Status: Indicator Found					
UCIP Comments: Need to contact owner to determine last inspection and status of crossing.					
FIELD_STRUCT_DESC: 2 of 2: 10-inch gas line through the levee, 2.0 feet below the crown. Cutoff wall around pipes at center of levee. Valve pit on landward shoulder, with 2-inch drain pipe along landward slope. Location marker on waterward slope. (Permit No. 960-1944) This entry matches the Drainage or Irrigation Structure referenced in O&M manual (HLM 2.04). Pipe video inspected by PG&E under Permit No. 15319 (1990).					
FS Date: 5/5/2009

Warning marker visible on waterward shoulder.

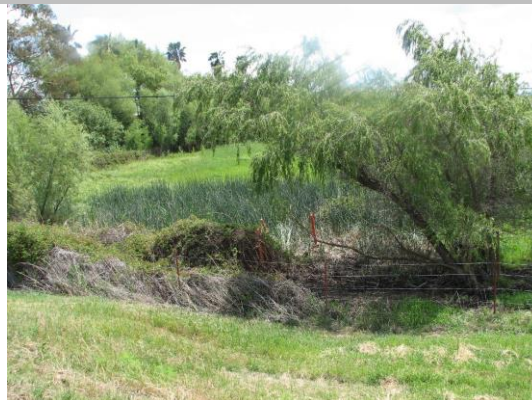
Photo 2 of 2 : UCIP_FA_2016_22098_37723.jpg

Markers also visible on landward side near levee toe.

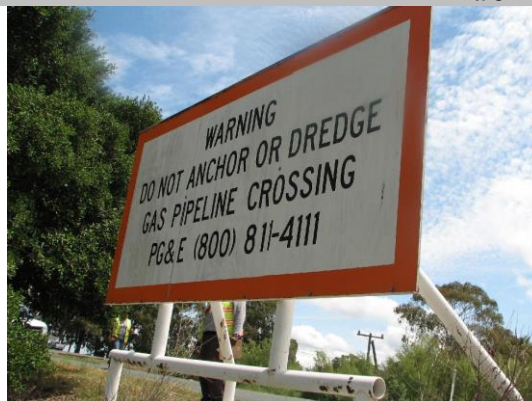
Photo 1 of 2 : UCIP_FA_2016_39860_71847.jpg

FS_ID:39860
DS_ID:24756
EP_NO: 17251
Repair Type: Non-Urgent
Crossing Status: Indicator Found
UCIP Comments: Need to contact owner to determine status of crossing. Need date of last inspection and confirmation that crossing is still in operable condition.
FIELD_STRUCT_DESC: 24-inch steel natural gas pipeline through the levee 125-feet below the crown (Permit No. 17251, 2002).
FS Date: 3/4/2014

View of sign located on waterward side.

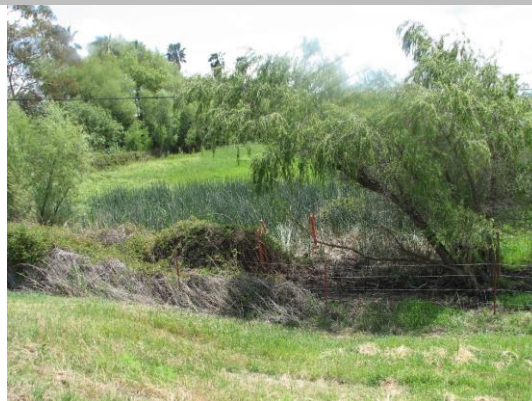
Photo 2 of 2 : UCIP_FA_2016_39860_71846.jpg

Markers visible on landward toe.

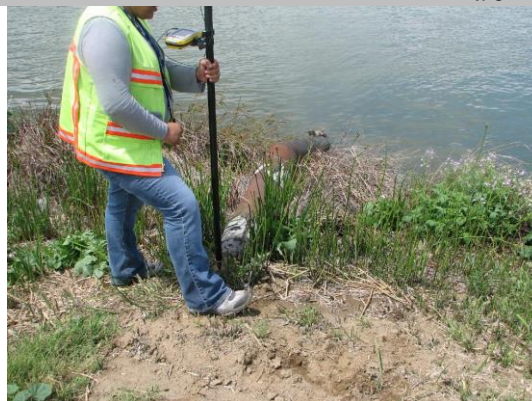
Photo 1 of 2 : UCIP_FA_2016_22106_37734.jpg

FS_ID:22106
DS_ID:24120
EP_NO: 11102
Repair Type: Non-Urgent
Crossing Status: Found
UCIP Comments: Dense vegetation limits the inspector's visibility to identify signs of pipe failure (leaks) along the slope. Recommend removing vegetation along pipe alignment to conduct proper inspection of structure and appurtenances.
FIELD_STRUCT_DESC: 10-inch pipe sleeved through 12-inch pipe through the levee, 4.6 feet below the crown. Annular gap grouted. Siphon breaker at landward shoulder. Pump on landward side. Irrigation canal with distribution box at landward toe. Rock revetment on waterward slope. This entry matches the Drainage or Irrigation Structure referenced in O&M manual (HLM 2.33). This pipe was retained under ABO No. 11102 (1975).
FS Date: 5/5/2009

View of pipe on waterward side.

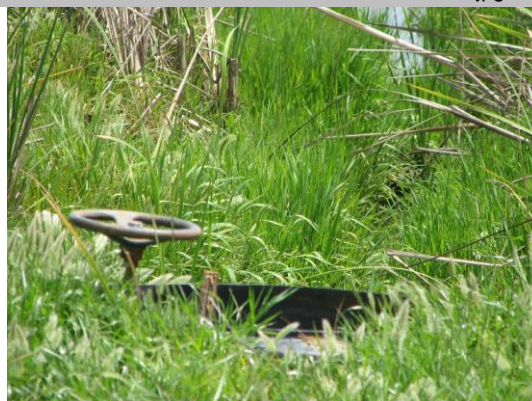
Photo 2 of 2 : UCIP_FA_2016_22106_37733.jpg

Riser and gate visible on waterward side--dense vegetation limits inspection.

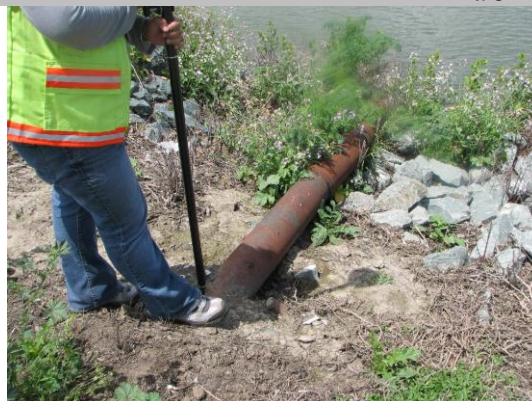
Photo 1 of 2 : UCIP_FA_2016_22112_37750.jpg

FS_ID:22112
DS_ID:24121
EP_NO: N/A
Repair Type: Non-Urgent
Crossing Status: Found
UCIP Comments: Pipe side does not match found 10 inch instead of 8 inch. Pipe (1 of 2) was supposed to be removed and replaced with 12-inch steel irrigation pipes under Permit No. 5629 (1966). Historical Levee Logs from 1992 do not reflect that the replacement was completed, verify diameter of pipes and status with applicant. Dense vegetation limits the inspector's visibility to identify signs of pipe failure (leaks) along the slope. Recommend removing vegetation along pipe alignment to conduct proper inspection of structure and appurtenances. FIELD_STRUCT_DESC: 1 of 2: 10-inch (not 8-inch as originally noted in records) steel irrigation pipe through the levee, 1.4 feet below the crown. Siphon breaker on landward side. Irrigation ditch with distribution box at landward toe. Pipe exposed on both slopes. Rock revetment on waterward slope. (USACE-1962). This entry matches the Drainage or Irrigation Structure referenced in O&M manual (HLM 2.93).

View of pipe and rip rap located on waterward side.

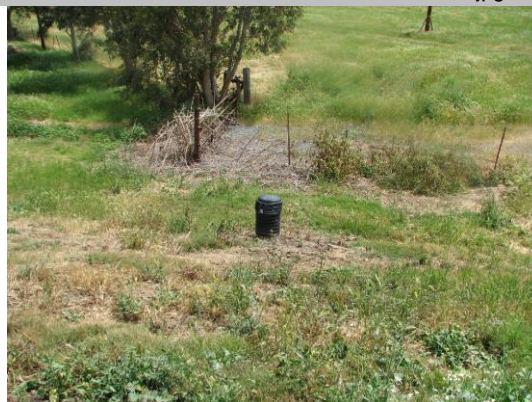
Photo 2 of 2 : UCIP_FA_2016_22112_37748.jpg

Stand pipe located near levee toe on landward side.

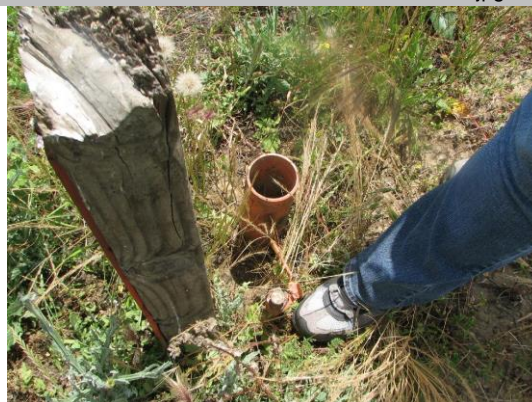
Photo 2 of 2 : UCIP_FA_2016_22116_37755.jpg

FS_ID:22116
DS_ID:24238
EP_NO: N/A
Repair Type: Non-Urgent
Crossing Status: Indicator Found
UCIP Comments: Pipe side does not match--found 10 inch instead of 8 inch. Pipe (2 of 2) was supposed to be removed and replaced with 12-inch steel irrigation pipes under Permit No. 5629 (1966). Historical Levee Logs from 1992 do not reflect that the replacement was completed, verify diameter of pipes and status with applicant. Dense vegetation limits the inspector's visibility to identify signs of pipe failure (leaks) along the slope. Recommend removing vegetation along pipe alignment to conduct proper inspection of structure and appurtenances. FIELD_STRUCT_DESC: 2 of 2: 10-inch (not 8-inch as originally mentioned in desk study) steel irrigation pipe through the levee, 1.6 feet below the crown. Siphon breaker on landward side. Irrigation ditch with distribution box at landward toe. Pipe exposed on both slopes. Rock revetment on waterward slope. (USACE-1962). This entry matches the Drainage or Irrigation Structure referenced in O&M manual (HLM 2.93). FS Date: 5/5/2009

Small stand pipe located on waterward side--unknown purpose of stand pipe.

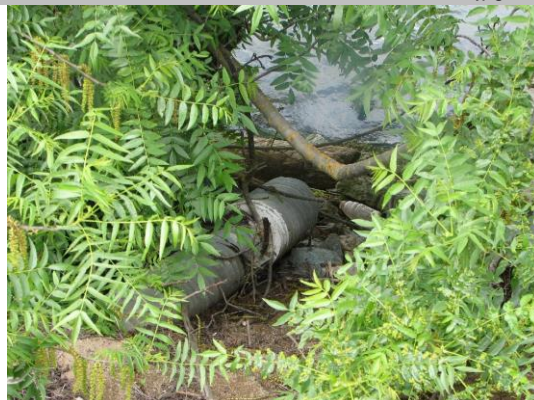
Photo 2 of 2 : UCIP_FA_2016_22183_37783.jpg

FS_ID:22183
DS_ID:24245
EP_NO: N/A
Repair Type: Non-Urgent
Crossing Status: Found
UCIP Comments: New crossing found in field--need to find owner and determine permit authorizing work.
FIELD_STRUCT_DESC: 10-inch corrugated metal pipe extruding from the waterward slope.
FS Date: 5/5/2009

Pipe on waterward side.

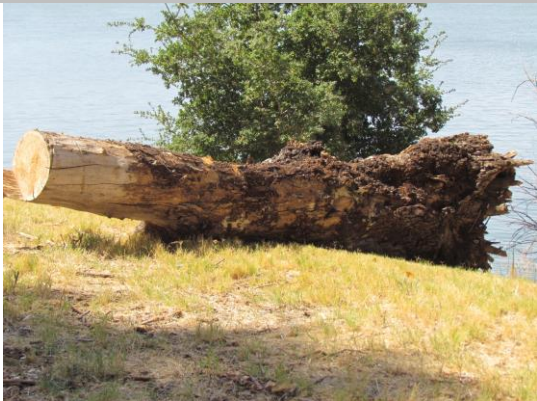
Photo 1 of 1 : FA_2016_RD0341_168_38_20160928_00076.jpg

RD 341 Waterside slope looking downstream levee mile 3.52.

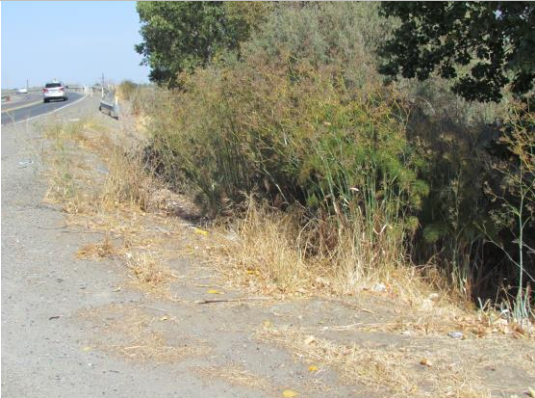
Photo 1 of 1 : FA_2016_RD0341_168_51_20160928_00081.jpg

RD 341 Looking at the landside slope levee 3.95-5.03 from upstream.

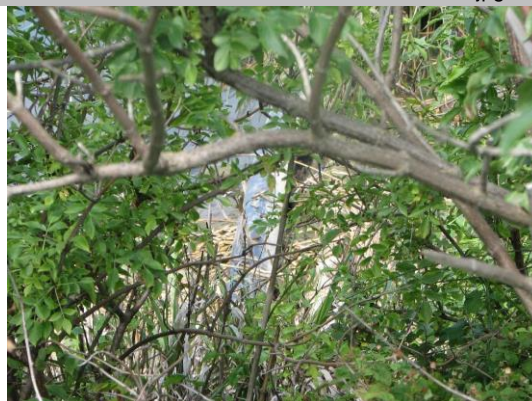
Photo 1 of 2 : UCIP_FA_2016_22203_37833.jpg

Comment Code						
Inspector Comment						
FS_ID:22203 DS_ID:24135 EP_NO: 11110 Repair Type: Non-Urgent Crossing Status: Found UCIP Comments: Need to determine status of crossing--need to contact owner. Dense vegetation limits the inspector's visibility to identify signs of pipe failure (leaks) along the slope. Recommend removing vegetation along pipe alignment to conduct proper inspection of structure and appurtenances. FIELD_STRUCT_DESC: 10-inch pipe sleeved through 12-inch pipe through the levee, 3.8 feet below the crown. Pump on concrete well on landward slope. (USACE-1962). This entry matches the Drainage or Irrigation Structure referenced in O&M manual (HLM 4.03). 10-inch pipe was retained under ABO No. 11110 (1975). FS Date: 5/6/2009

Limited access to waterward side--pipe visible through brush.

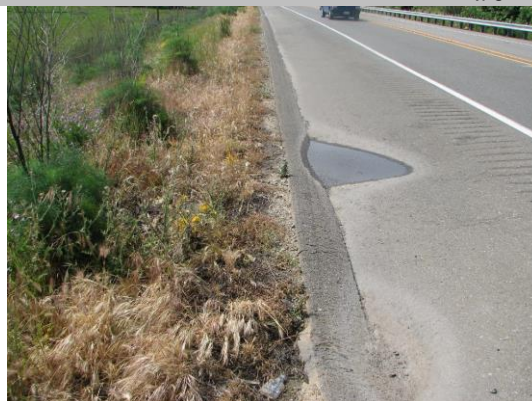
Photo 2 of 2 : UCIP_FA_2016_22203_37832.jpg

View of landward shoulder and low spots on highway.

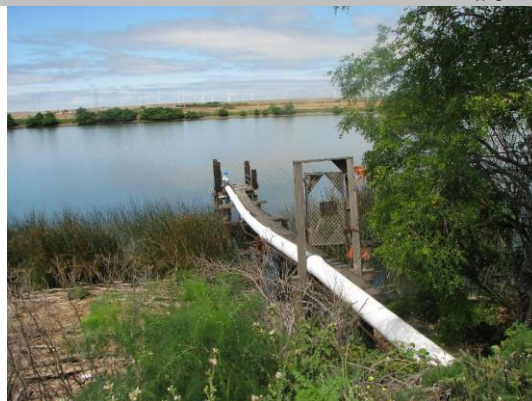
Photo 1 of 1 : UCIP_FA_2016_22223_37840.jpg

View of waterward side--pipe and pump visible.

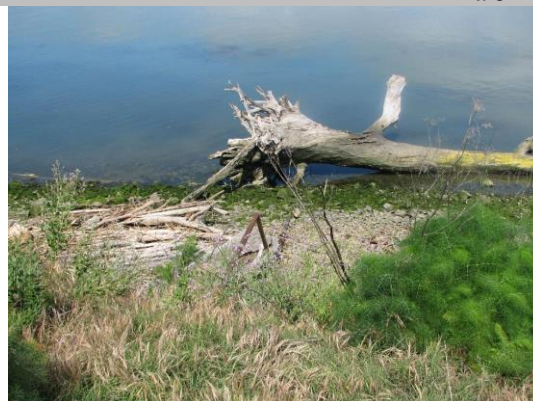
Photo 1 of 2 : UCIP_FA_2016_22186_37787.jpg

View of crossing on waterward side--dense vegetation on slopes.

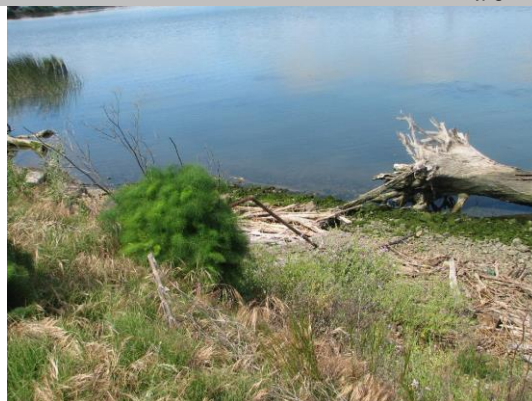
Photo 2 of 2 : UCIP_FA_2016_22186_37786.jpg

View of waterward toe.

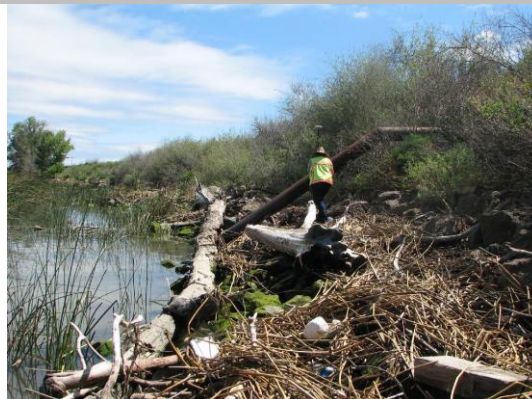
Photo 1 of 2 : UCIP_FA_2016_50009_37842.jpg

View of crossing on waterward side. Dense vegetation limits inspection of crossing.

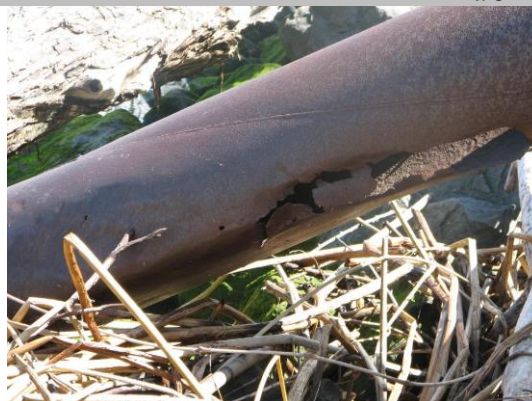
Photo 2 of 2 : UCIP_FA_2016_50009_37841.jpg

Holes present on waterward side.

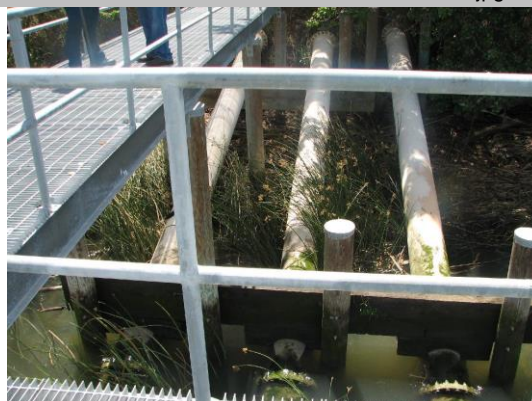
Photo 2 of 2 : UCIP_FA_2016_22253_37882.jpg

View of waterward side - 3-20 inch pipes.

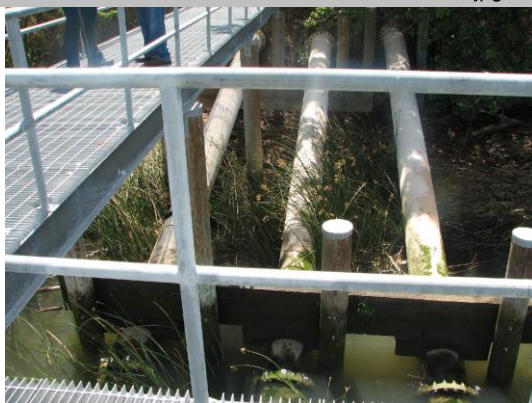
Photo 2 of 2 : UCIP_FA_2016_22254_37898.jpg

View of waterward side - 3-20 inch pipes.

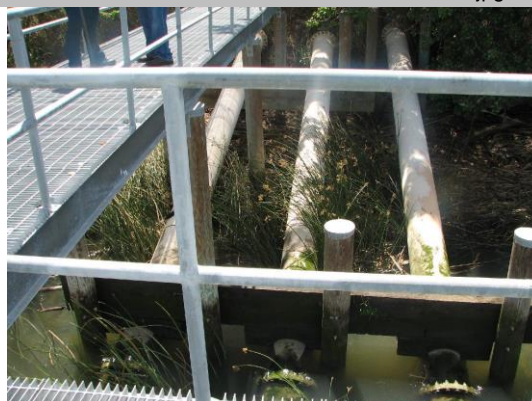
Photo 2 of 2 : UCIP_FA_2016_22255_37909.jpg

View of waterward side - 3-20 inch pipes.

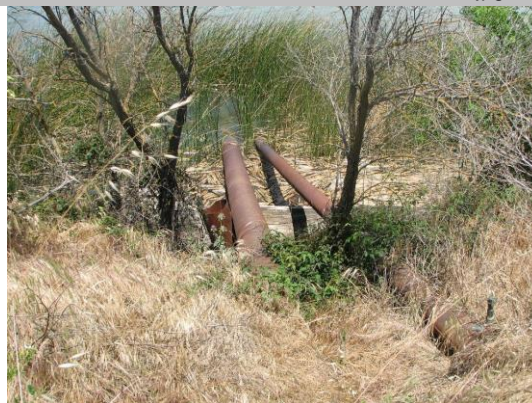
Photo 1 of 2 : UCIP_FA_2016_22258_37932.jpg

8-inch pipe and 14-inch pipe on waterward side.

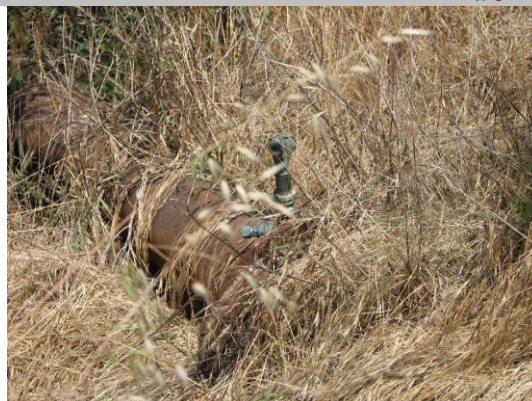
Photo 2 of 2 : UCIP_FA_2016_22258_37930.jpg

Air vent located on waterward side.

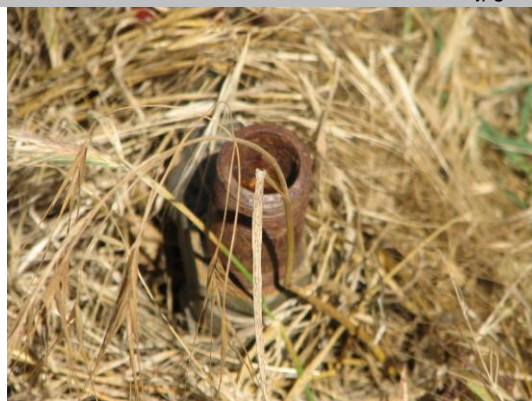
Photo 2 of 2 : UCIP_FA_2016_22259_37936.jpg

Air vent located on waterward side.

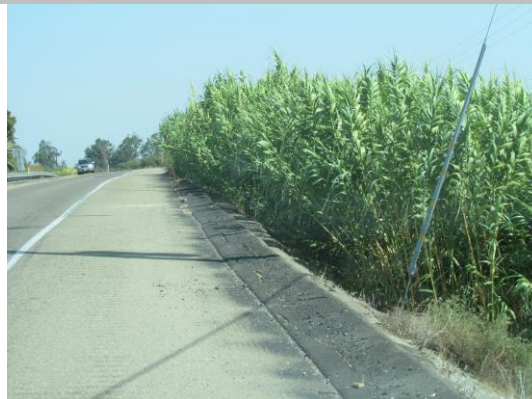
Photo 1 of 1 : FA_2016_RD0341_168_49_20160928_00078.jpg

RD 341 Landside slope from levee mile 6.03-6.10.

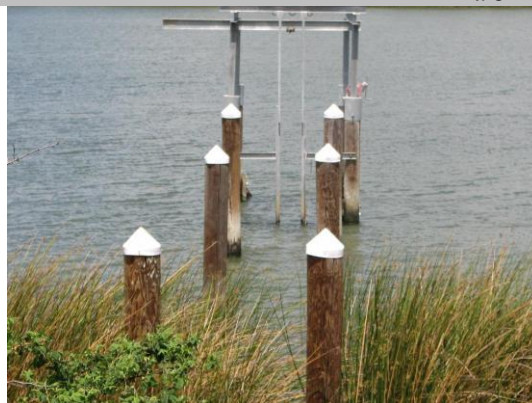
Photo 1 of 2 : UCIP_FA_2016_39861_71853.jpg

View of structure located on waterward side.

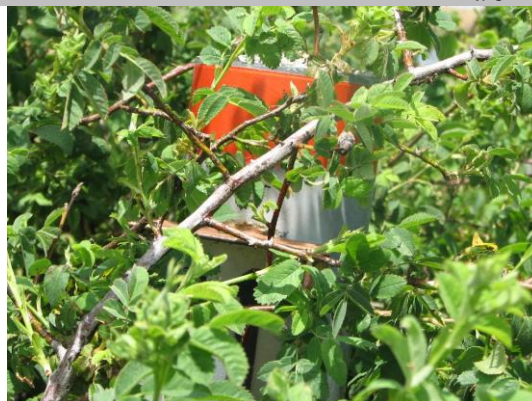
Photo 2 of 2 : UCIP_FA_2016_39861_71852.jpg

Marker visible on waterward side associated with crossing.

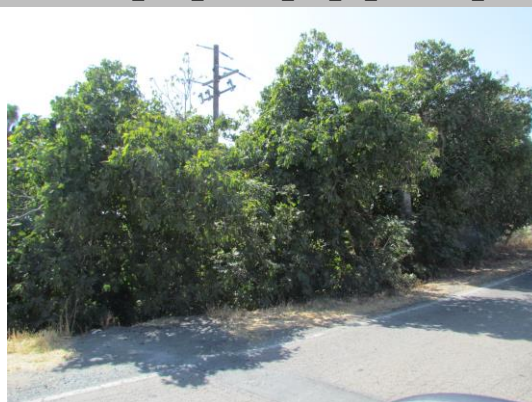
Photo 1 of 1 : FA_2016_RD0341_168_47_20160928_00079.jpg

RD 341 Landside levee slope levee mile 6.29-6.32.

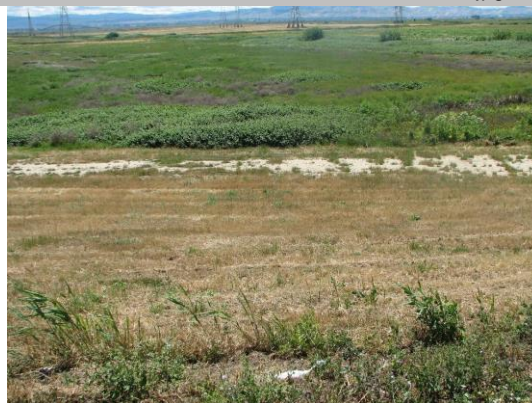
Photo 1 of 2 : UCIP_FA_2016_22262_37953.jpg

View of landward side no evidence of crossing.

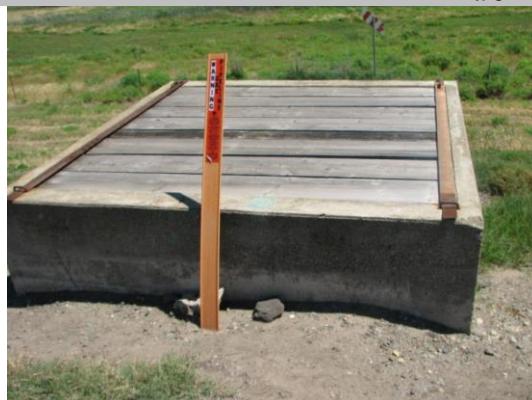
Photo 1 of 2 : UCIP_FA_2016_22263_37962.jpg

View of landward side. Concrete box and markers indicating gas pipeline. Additional marker located at levee toe.

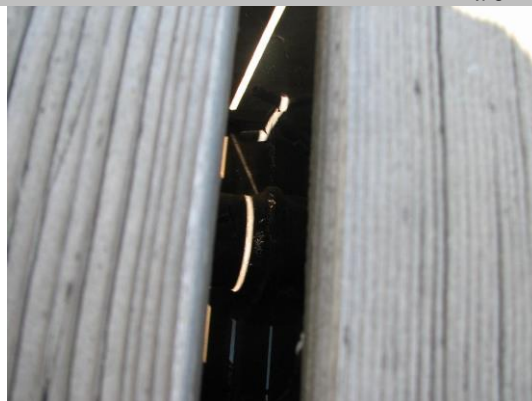
Photo 2 of 2 : UCIP_FA_2016_22263_37961.jpg

Unable to confirm number of pipes.

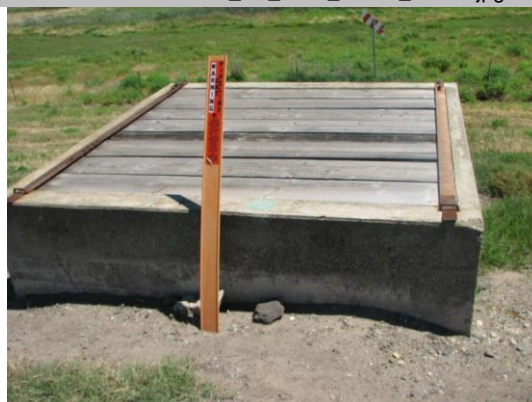
Photo 1 of 2 : UCIP_FA_2016_22264_37965.jpg

Concrete box and marker located on near landward shoulder. Additional marker located at the levee toe.

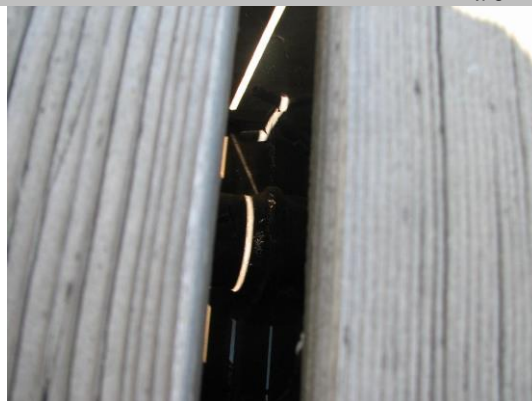
Photo 2 of 2 : UCIP_FA_2016_22264_37964.jpg

Unable to confirm the number of pipe through section of levee.

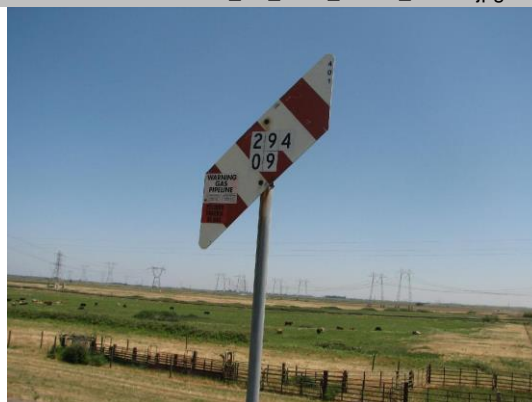
Photo 1 of 2 : UCIP_FA_2016_22267_37978.jpg

Marker located on landward side.

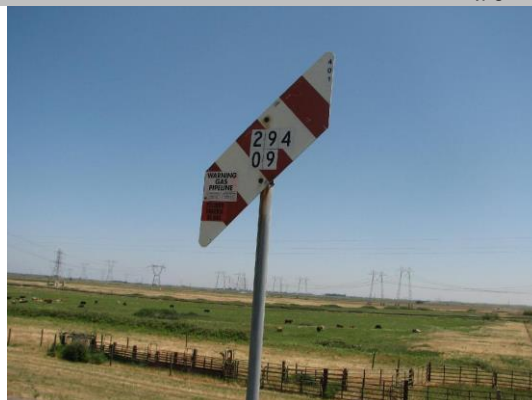
Photo 1 of 2 : UCIP_FA_2016_22268_37980.jpg

Utility marker located on landward side.

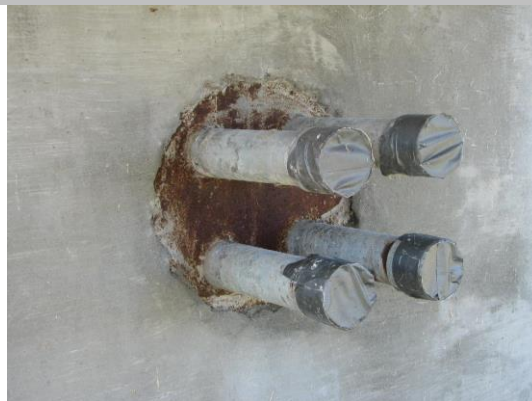
Photo 2 of 2 : UCIP_FA_2016_22303_38061.jpg

Conduits exposed on waterward side.

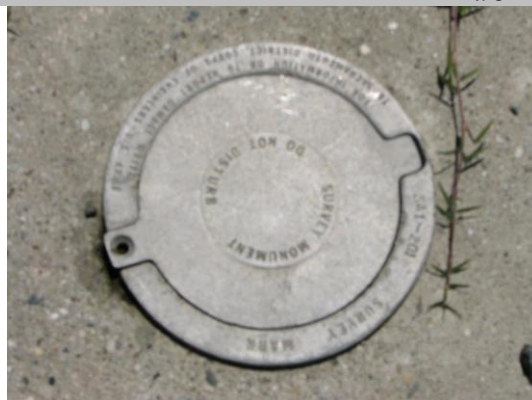
Photo 1 of 2 : UCIP_FA_2016_22307_38070.jpg

Surve marker located at site.

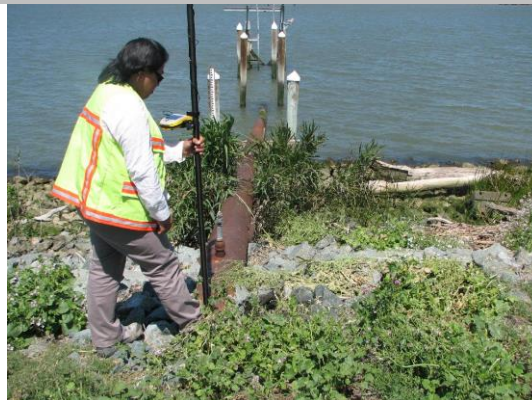
Photo 2 of 2 : UCIP_FA_2016_22309_38076.jpg

Overview of crossing on waterward side.

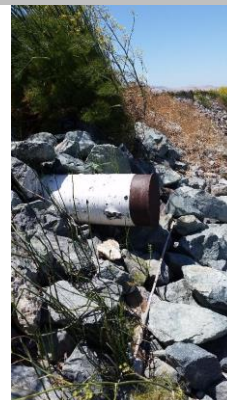
Photo 2 of 2 : UCIP_FA_2016_50082_75942.jpg

New pipe(non-functional) metal plate installed on the WS.

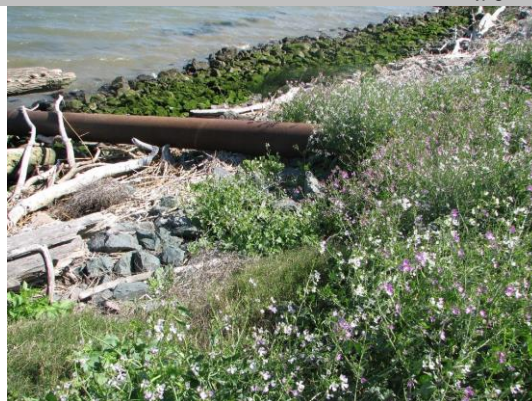
Photo 1 of 2 : UCIP_FA_2016_22324_38096.jpg

Overview of waterward side.

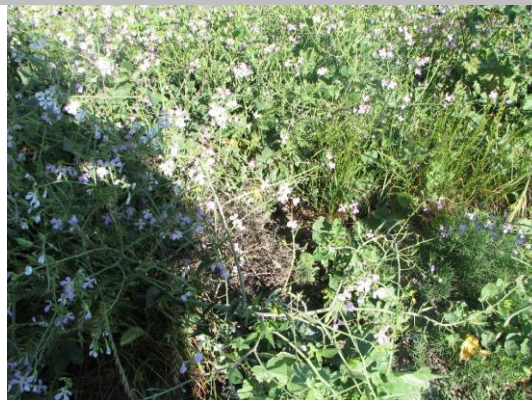
Photo 2 of 2 : UCIP_FA_2016_22324_38095.jpg

Potential subsidence in slope however difficult to determine due to dense vegetation.
